TREES WITHIN/NEAR THE BUILDING FOOTPRINT ON THE ALLOTMENT

CQ SOIL TESTING

Title: **CONTOUR & SITE PLAN**

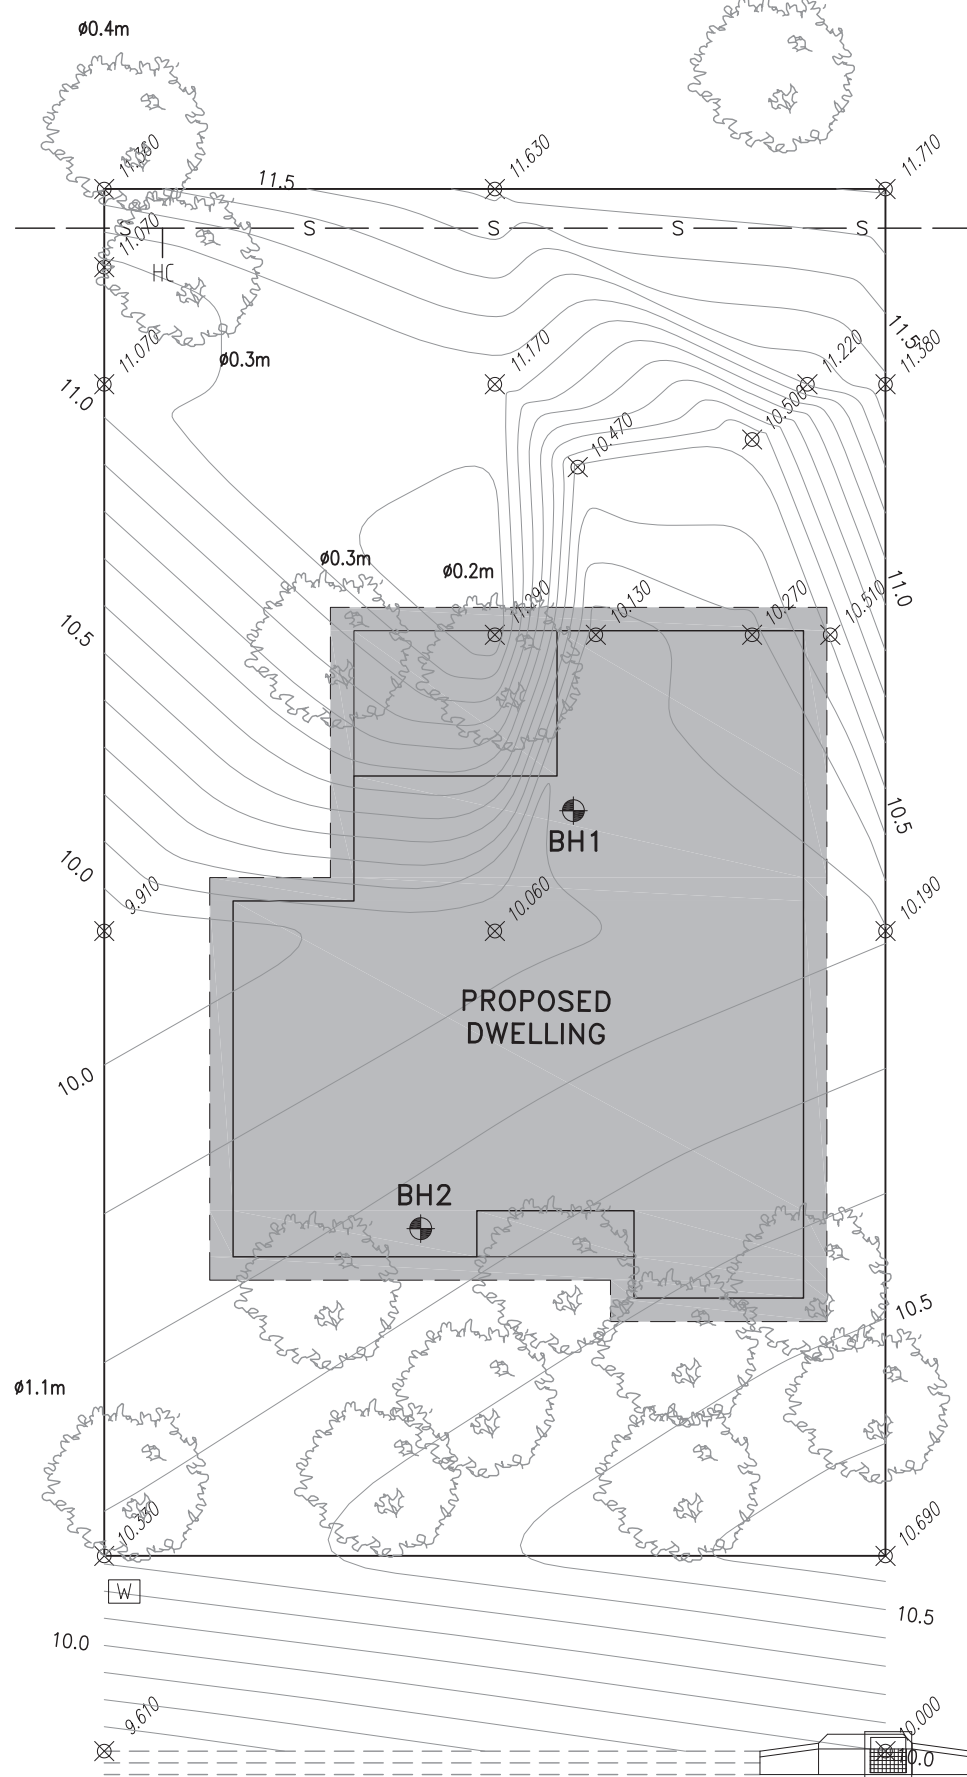
Inside Footprint &
Outside Footprint (within the allotment boundary)

- CQ Soil Testing recommend the above mentioned trees are to:
- Be removed,
 - Have their root bowl area over-excavated to a suitable foundation material,
 - Be backfilled (using a material similar to that found on site) and compacted using appropriate construction methods.

Trees outside the proposed building footprint may remain if a suitable impenetrable root barrier is installed to the engineers details.
